Inspection of Churches Measure 1955

Church of St Mary Magdalene, Huntshaw

Diocese of Exeter

Inspected by **John Alexander** BA DipArch MSc RIBA AABC

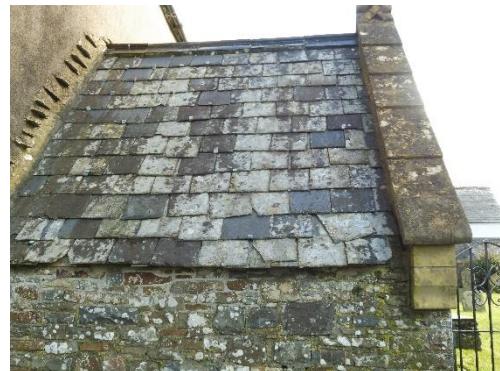
- 3.1 Generally natural slate, 8" x 16" Cornish slates with later Welsh slate patch repairs. Glazed black ridge tiles the majority of which have a roll top. 19th century parapet to the east end of the chancel.
- 3.2 **West pitch of porch** – the fixings to the slates have reached the end of their lives. A large number of clipped slates, some of which have slipped. Weathering will need to be renewed within the next 2 years.

3.3 **East pitch of porch** – slightly better than the west pitch, but the fixings have also reached the end of their lives and will need to be renewed in the next 2 years. Mortar falling away from ridge tiles.

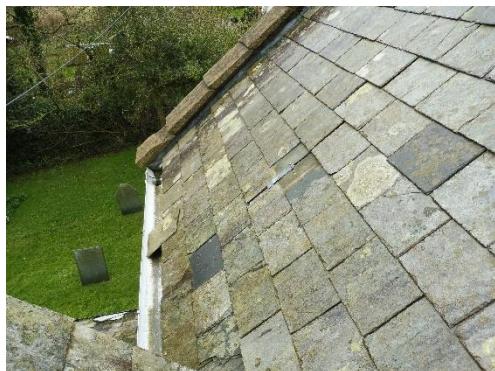
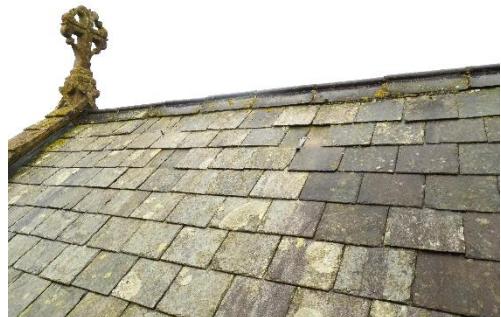
3.7 **North pitch of chancel** – 5 slipped slates, leaving the roof vulnerable to water ingress.

3.8 **The chancel roof** – ought to be re-slated within the next 2 years, to protect this part of the building.

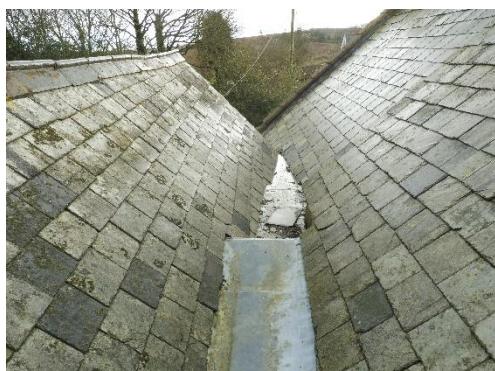
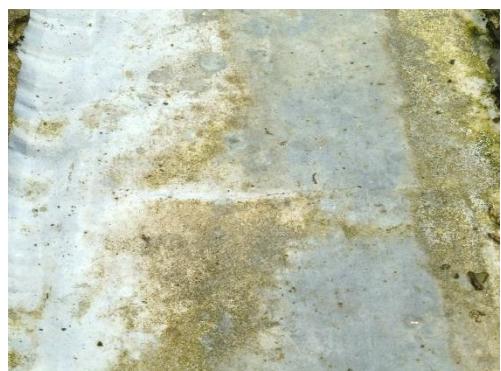
3.9 **Lead valley gutter** – falls westward from the chancel arch towards an outlet north of the tower. Lead runs down 2 steps, the detailing of which could be improved to this section of lead.

3.10 2 bays with a single step, runs from the chancel arch to the east. Lead flashing to the north gutter of the chancel. Lead has now reached the end of its life. Larger bays have a number of thermal fractures, which will be letting small amounts of water in, a slight depression on the lowest bay at the west end, is collecting organic debris.

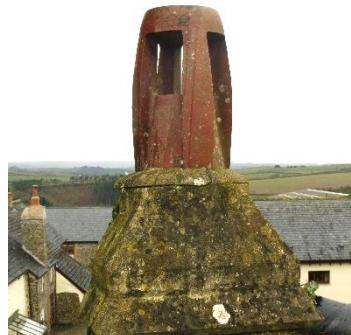
3.14 **Chimney** – at west end of north aisle. Ceramic pot is loose and potentially could blow off. This needs to be re secured with new cement flaunching, which is now fractured and loose.

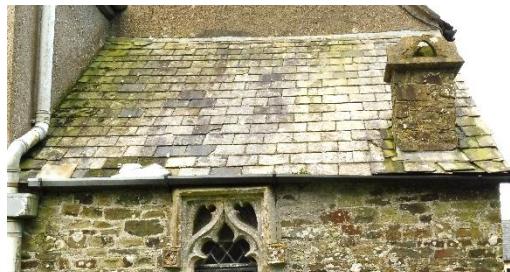
3.17 **Lean to roof to vestry** – generally intact, although there are a number of slipped and damaged slates, particularly around the vestry chimney stack.

3.18 Slates to the verge on the northern end of the roof are too small to stay in place and this roof will need to be renewed within 2 years. B

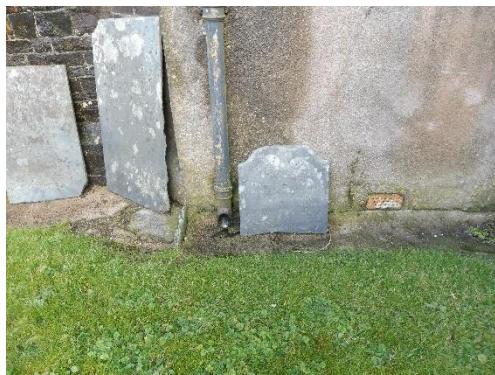
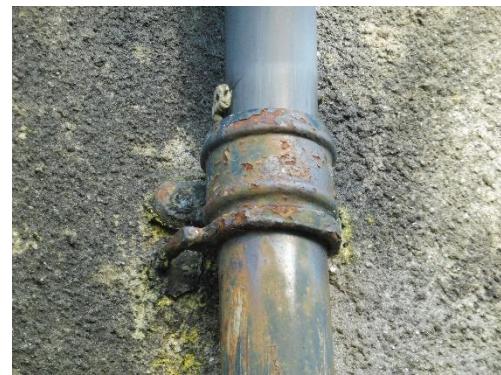
4.1 The older cast-iron rainwater goods originate from the 19th century. These are cast iron gutters and downpipes that have been replaced on the southern eaves with PVC gutters. All existing cast iron rainwater goods will need to be repainted within the next 2 years and ideally the plastic rainwater goods upgraded to longer lasting cast iron. B

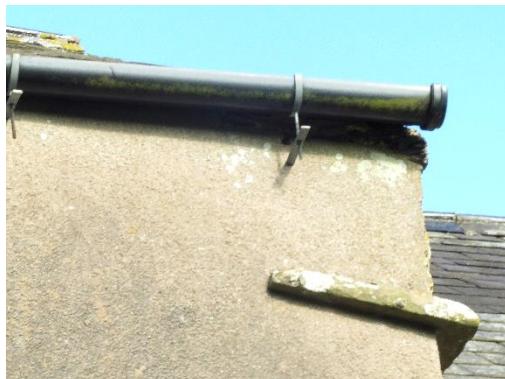
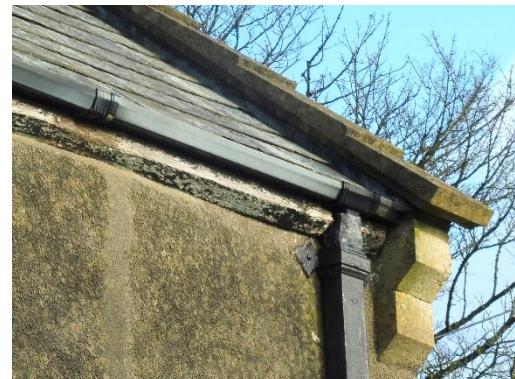
- 4.2 The PVC gutters are generally undersized to the chancel and have been fitted too closely to the slate line at the eaves. These need to be upgraded. B
- 4.3 Square black PVC gutter to the eaves of vestry roof requires cleaning and is very close to the slate line causing it to block and preventing it from draining properly. The northern end has dropped. Black PVC downpipe to the east eaves of the vestry will need to be upgraded as this has dropped at the northern end.

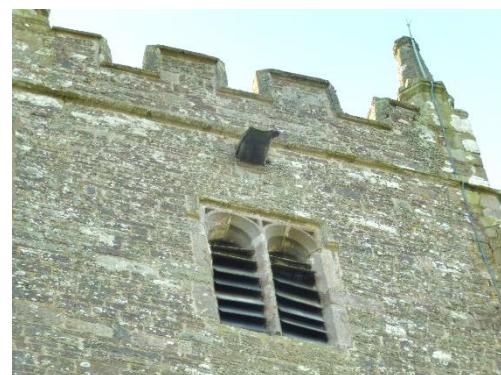
- 4.4 The black PVC downpipe to the north wall of north aisle at the eastern end has a broken bracket at base and requires a shoe to direct the water away from the masonry of the building. B
- 4.5 The fixings to the cast iron rainwater downpipes on the north west corner of the north aisle needs to be secured. B
- 4.6 The tower roof drains to a chute on north wall. Due to the size of this chute and the height of the tower the majority of the rainwater from the tower roof hits the north wall of the tower before it hits the ground. The church should consider either extending the chute or fitting a new hopper head and downpipe to minimise the penetrating damp to the masonry of the tower. C
- 4.7 There are no gutters to the porch roof.

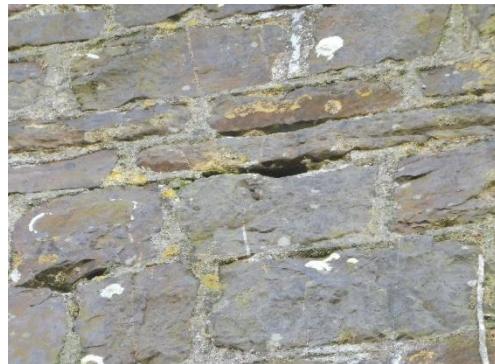
7.10 **West wall of tower** – a number of open joints at all stages would need to be maintained on a rolling basis, ideally with a contract signed up with a rope access contractor. Who could do small areas at a time when the church could afford it. This being the most weathered face of the church will need to have a rolling programme of maintenance to maintain the joints with appropriate lime mortars.

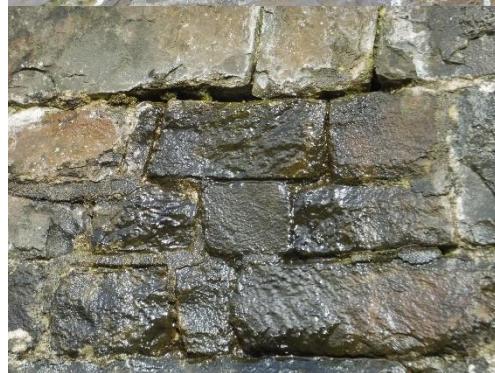
7.11 **South wall of the tower** – again a number of open joints in the mortar, particularly evident in the lower stage where water that has found its way into the core masonry has seeped out. This is very evident on the day of inspection. This would indicate that the masonry could benefit from a certain amount of grouting after some careful testing and specification work. Other stages also have a number of significant open joints to the masonry, which will only exacerbate the inherent damp within the masonry.

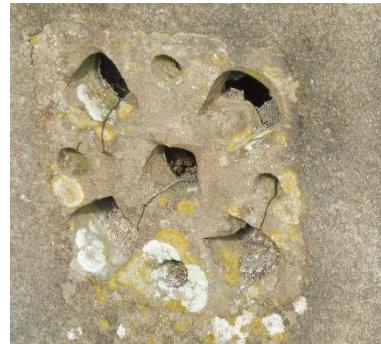
9.6 Perforated vent stone below the window is generally in good condition, however the insect mesh has now decayed entirely and remains of the mesh should be removed and some other means of protecting this void to be established.

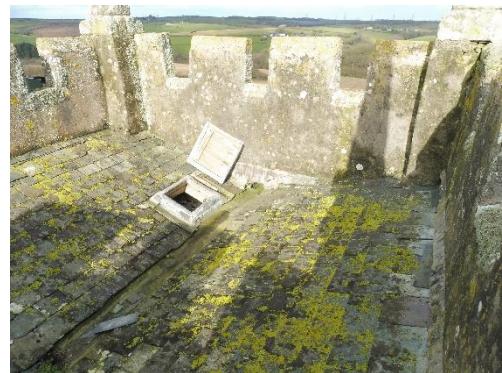
10.4 The lead valley is in sandcast lead which is now reaching the end of its life and has previously been repaired with several welted patches. However, it is currently intact but requires some cleaning to make sure it remains free draining.

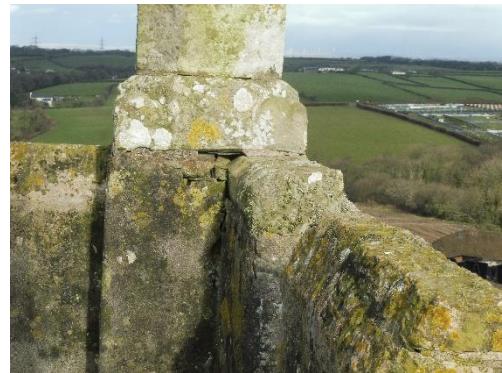
10.6 Masonry to the parapet wall has been rendered internally, some of this render is now falling away and exposing the joints of the rubble masonry below. Noticeably in the north east corner below the pinnacle.

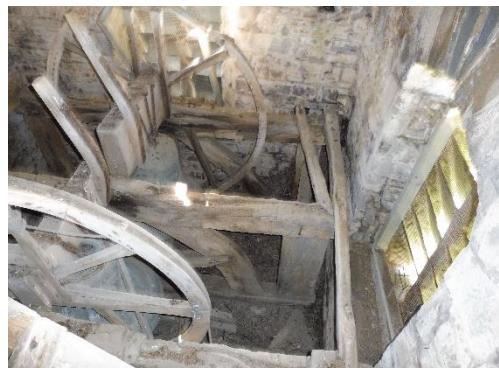
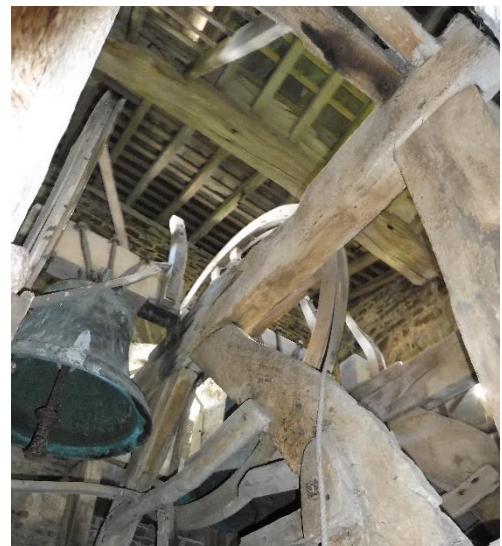
10.9 **Bell chamber** - The masonry to the walls appear structurally sound with tight mortar joints and is very well built. There is minimal bird debris in the chamber and the bird mesh appear intact.

10.10 **Deadening chamber** – A blocked east window and the floor has been removed with a later inserted lower ceiling to the ringing chamber at the base of the tower. The masonry appears in sound condition and reasonably dry even though this space isn't particularly well ventilated. A minor fracture and some damage to the lintel over the now redundant door into the deadening chamber should be monitored for any ongoing movement.

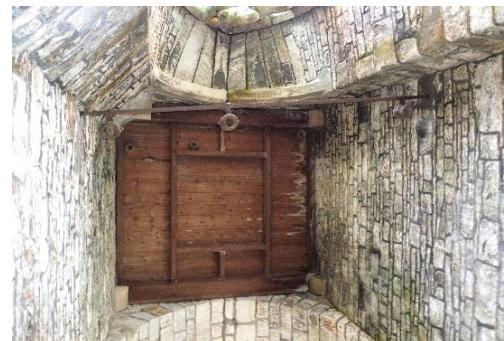
10.13 19th century ceiling has been inserted directly above the west window opening on new bracket stones. Some decay and water staining to the boards adjacent to the south wall but otherwise generally sound. This deck is not accessible from above and therefore structural not quite so critical but these boards will should be repaired within the next 5 years.

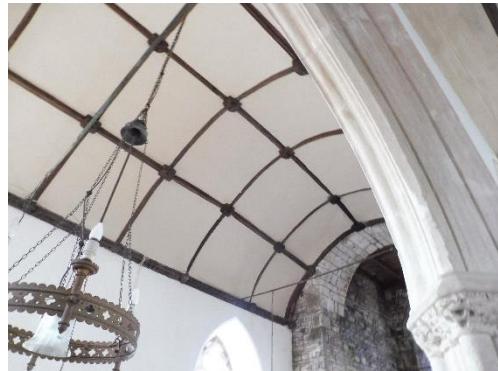
- 12.1 Late 15th / early 16th century wagon roof to nave with moulded oak ribs and rails intersecting at relatively simple bosses. Carved wall plate in oak. All appears in good condition. Some timber decay has filtered down between the rib adjacent to the chancel arch and the masonry depositing dust and frass on the surface of the wall.

- 12.2 Paint finish to the panels of the nave ceiling at the western end is starting to peel away. The decoration to the ceiling will need to be addressed within the next 5 years. Signs of some impaction to the plaster on the south wall plate of nave ceiling. These manifest as cracks and bulges within the plaster. This would indicate an ongoing small amount of decay to the timber structure supporting the ceiling and roof, which should be monitored.

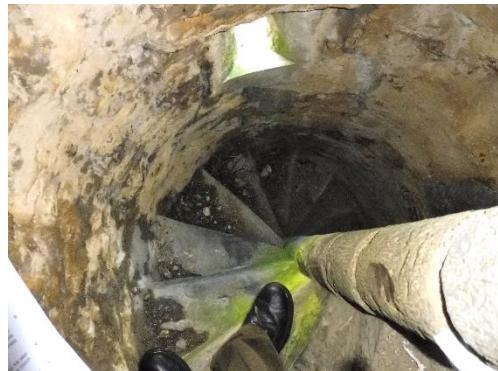
- 13.1 Turret stair requires a clean to make it safer for access. Some of the treads are quite worn and are subject to water ingress through the stair lights, but generally if cleaned provide reasonable access up to the bell chamber.

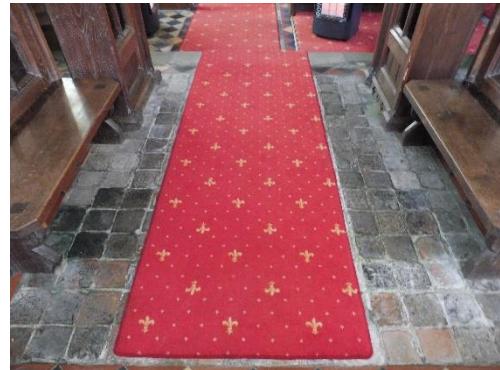
- 16.1 Generally - the floor was constructed in the late 19th century restoration. Much of the nave and north aisle has been tiled in plain ceramic tiles set in diamond patterns and earlier encaustic Barnstaple tiles have been reused in the chancel leading to a marble sanctuary step at the altar rail with more 19th century decorative tiling on the sanctuary floor. The stone to the aisles have been covered with carpet which appears to cover old monument stones but seems in good condition.

- 16.2 All ceramic tiles appear to be sound and no obvious areas of loose tile or damage other than adjacent to the old cast iron coke heater at the west end of the north aisle, where there are a number of cracked and damaged 19th century tiles.

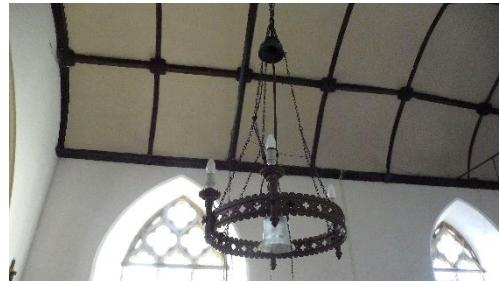
- 22.2 The original church was gas lit to 19th century chandeliers in the nave and suspended oil lamps in the north aisle. These have now all been converted to electric light, but remain an important part of the 19th century church building.

- 22.3 One or two bulbs are no longer operational in the chandeliers as part of the replacement of the bulbs, they should be upgraded to more energy efficient led alternatives that can run off mains power.

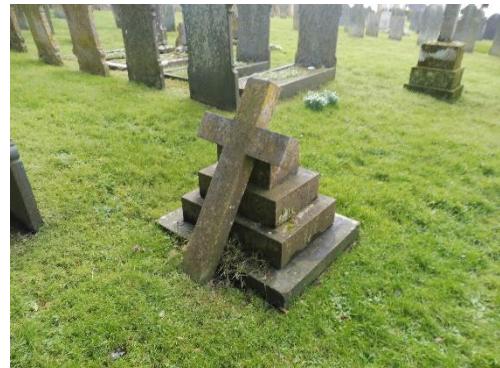
- 33.1 There are one or two leaning headstones. The monuments in the churchyard are generally in very good condition.
- 33.2 A crucifix has been laid off its plinth adjacent to the northern boundary. Similarly, a slate 'book' plinth has become dislodged adjacent to the footpath on the northern boundary.

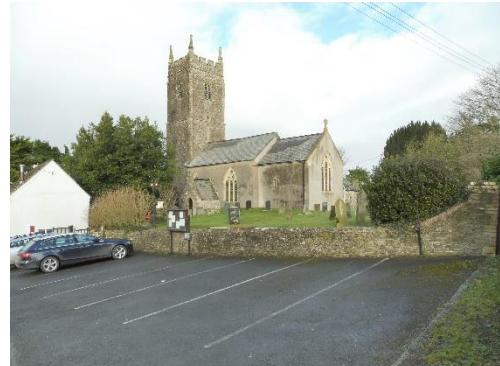
- 34.1 Hedge banks which act as retaining walls to the north, south and eastern boundaries. More defined retaining wall runs along the southern boundary to an adjoining village property and the car park.

- 34.2 Brick plinth to the pedestrian gate in the south eastern corner of the churchyard is now falling apart and will need to be rebuilt to secure it within the next 2 years.

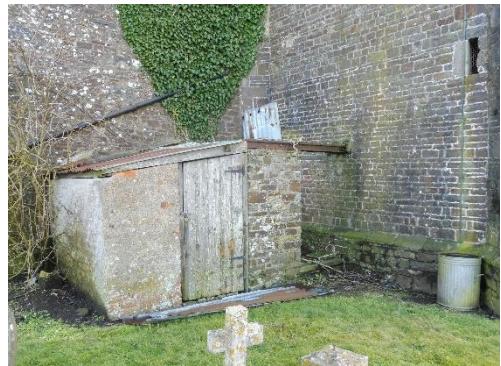
- 37.1 Lean-to structure between north wall of the tower and the west wall of the north aisle. Corroded steel joist is set into the masonry of the north wall of the tower. This should be removed before it damages the masonry. Debris and vegetation should be removed from between lean-to shed and the north wall of the tower.

- 37.2 If the structure is removed, it will allow for better access up to the central valley gutter without the risk of damaging the vestry roof.
- 37.3 Shrub stump at the northeast corner of this structure should be carefully removed. C
