# **CHURCH OF ST MARY MAGDALENE**

# **HUNTSHAW**

## **REPORT ON THE CONDITION OF THE BELLS, BELL-FRAME AND FITTINGS**

Inspection carried out on Tuesday 7<sup>th</sup> March 2017 by David Hird (Assistant to the Exeter DAC Consultant on Bells and Clocks) and Ian Campbell and Ian Smith (Bells and Belfries Advisors to the Guild of Devonshire Ringers), assisted by Robert Franklin; met by Peter Denard (Church Treasurer). This report also makes reference to the findings of Prebendary John Scott, former Bells Advisor to the Diocese of Exeter, from his visit in December 1979.

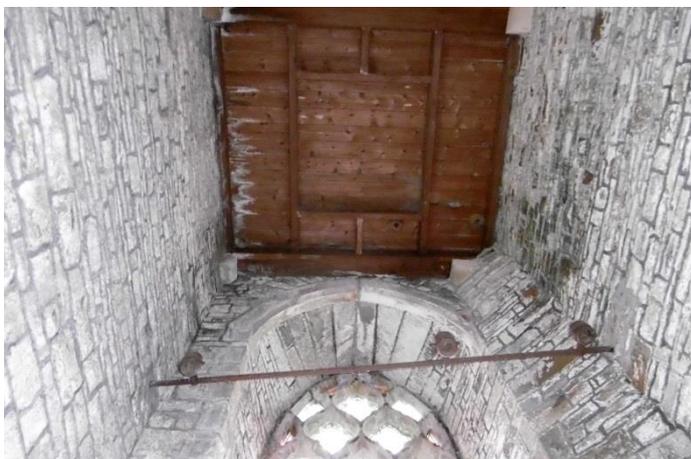
The ceiling is boarded and is supported by two main beams running N/S and resting on corbels built into the N and S walls. Some of the boarding on the S side appears to be affected by damp. Three rope holes can be seen in the W side of the ceiling just inwards of the W wall. A metal rope guide with wooden inserts spans the W side of the chamber approximately 15 feet above floor level, though no ropes are present. The guide is secured into the N and S walls.

*The Ground Floor Chamber looking up, showing the Metal Rope Guide, the Rope Holes in the Ceiling, and the damp affected boards on the S side*

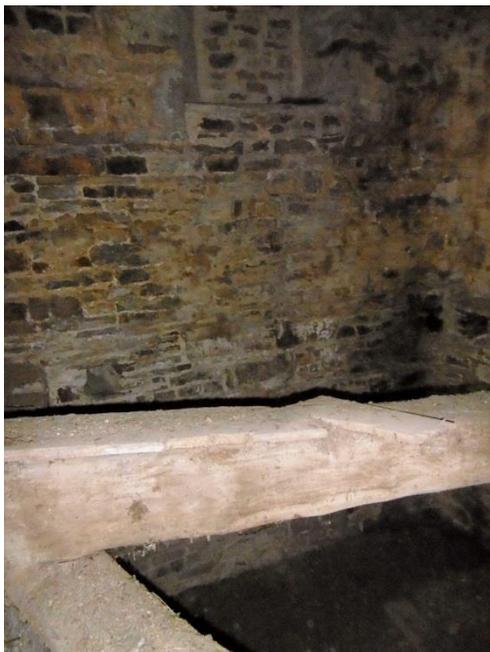
*The Intermediate Chamber*

The ceiling of the chamber is supported by six oak beams running N/S and resting on the higher offset of the tower walls. These beams also form the foundation for the bell-frame above and several securing bolts can be seen penetrating them. We were not able to examine these beams closely and so cannot comment as to their integrity.

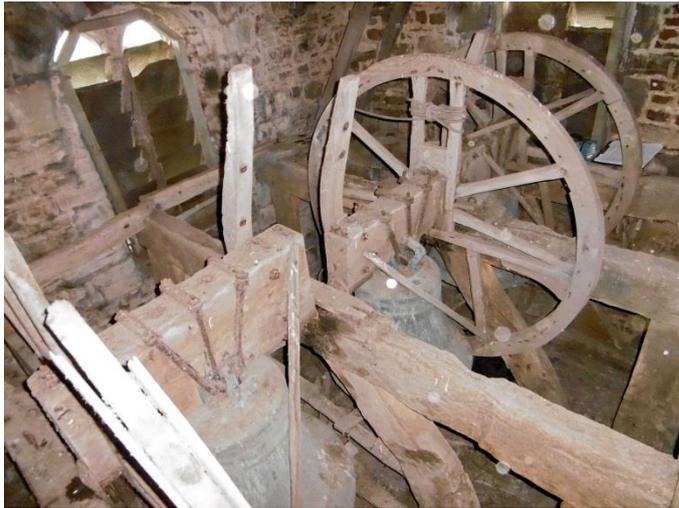
*The Bell Chamber*

The **Bell Chamber** is reached by means of a further 14 steps in the tower stairway. This chamber measures 11 feet 11 inches N/S by 10 feet 8 inches E/W and is 11 feet high to the base of the roof timbers. Each face of the chamber is pierced centrally by twin louveres with slats of slate, all covered internally by ½ inch weldmesh on a wooden framework. The mesh and framework over the S louveres had fallen inwards and was resting against the wheel of the tenor bell at the time of our visit. This should be re-secured. The louvere cills and the floor of the chamber, as with the stairs, have a significant covering of dust and other debris which

should be cleaned away. The chamber is almost totally occupied by the bell-frame which sits quite closely to the walls on all four sides.

1. Clear all dust, debris and bird nesting material from the tower stairs and the bell chamber.
2. If deemed safe to do so, clear the intermediate chamber of all dust and debris, as its presence will only serve to harbour damp and encourage the proliferation of wood-boring insects.
3. Secure the mesh and wooden framework over the S louvre in the bell chamber.
4. Carry out repairs to the return frame head at the W end of the tenor pit to prevent the side frames from spreading.

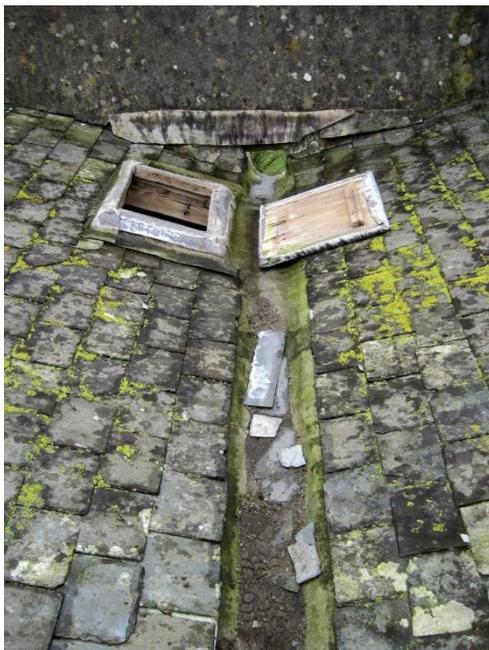
The **Roof** is supported by one main beam running centrally N/S from which rafters run up to the E and W walls. The roof is accessed by means of a wooden ladder running from the return frame head at the W end of the pit for the treble bell. The lead covered trap onto the roof is not fixed or hinged and is heavy to open. The roof is slated; one slate had slid out of

position such that light could be seen through the roof from the bell chamber. This was replaced and temporarily fixed by the rather weak clip that previously held it in position. Several other broken pieces of slate were loose in the central gully which empties to the spout on the N face of the tower.

*The Roof with Access Trap Open, showing various broken pieces of slate in the central gully*

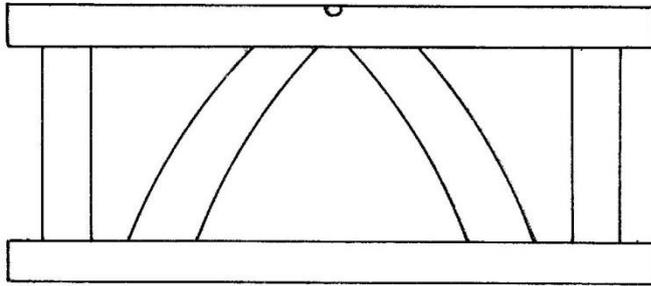
*Standard Side Frame Truss*

There is significant decay in some parts of the frame; indeed part of the return head at the W end of the tenor pit broke away as we were recording it. Having said that, the frame stands well and is reasonably robust. Various strengthening measures have clearly been taken over

the years, including a rather slender king-post inserted under the S bearing of the tenor bell, and an additional strut across the W end of the tenor pit.

The bearings were superficially cleaned out and oiled, and the bells were manually swung to about one-third height, it being deemed inappropriate and imprudent to attempt to swing them any higher due to the state of decay of the installation generally. The bearings were clearly functioning well and no undue looseness was detected in the fittings. The bell-frame appeared reasonably robust, in spite of its obvious state of decay, and surprisingly little flexing was encountered. We would conclude from this that the bell installation is quite safe in its static state, though it would be wise to carry out repairs at the W end of the tenor pit to negate any chance of the side frames spreading apart.

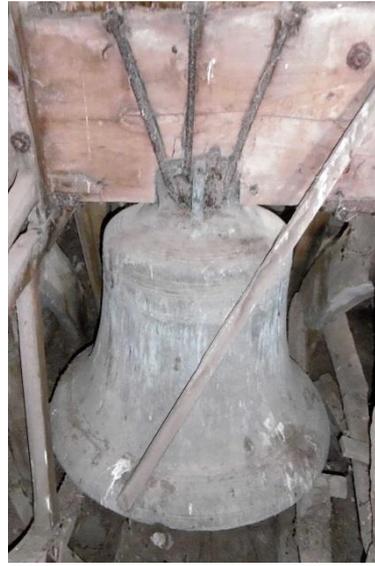
The **Bells** are somewhat mixed tonally. We would describe the treble as being somewhat indifferent, the second quite poor, and the tenor good. All the bells retain their cannons (supporting loops), though one of the single cannons on the tenor is broken. The second bell has a crack emanating in the crown and travelling towards the waist on the N side, this contributing to its poor tone. None of the bells has been turned so as to distribute wear at the point of clapper strike, though, having said that, none are particularly indented at the present point of strike. This would indicate that the bells have not been heavily used over the years.

*The Second Bell by John  
Pennington 1665*

All the bells retain their cast-in **Crown Staples** from which the clappers hang. The presence of cast-in staples is a common cause of bells becoming cracked – as has happened here to the second bell – due, firstly, to corrosion in the staple itself and, secondly, to the differential expansion between the iron of the staple and the bronze of the bell. Whenever major bell restoration takes place it is now standard practice for cast in crown staples to be cut off and their stubs thoroughly drilled out, and to be replaced with independent clapper staples bolted through a stress-relieving hole in the crown of the bell.

Whichever approach is taken it would be advisable to have the old crown staples removed from the bells to reduce any chance of future cracking, and to have the second bell welded, this being already cracked.

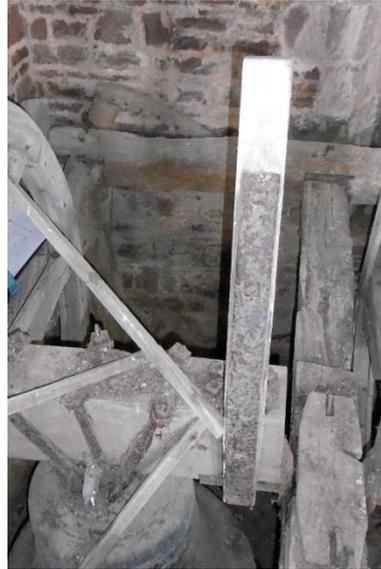
The **Stays** are of curved design and are each secured to their respective headstock by means of two single bolts. All the stays are reinforced with iron straps. This is inappropriate, as

the stay is designed to act as a safety valve, breaking under excessive force and so preventing more catastrophic damage to the crown of the bell.

*Reinforced Stay on the Treble Bell*

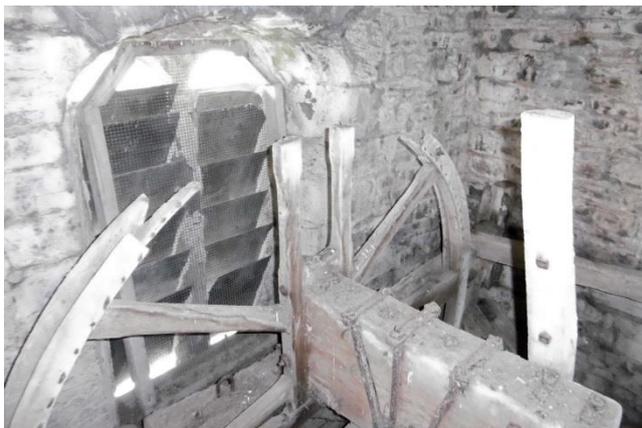
are very loose and starting to come adrift. The wheel on the second bell appears in similar condition to that on the treble, but is distinctly more rickety. The tenor wheel is in poorest condition, and part of the upper portion of the rim has completely broken away.

*Broken Wheel on the Tenor Bell*

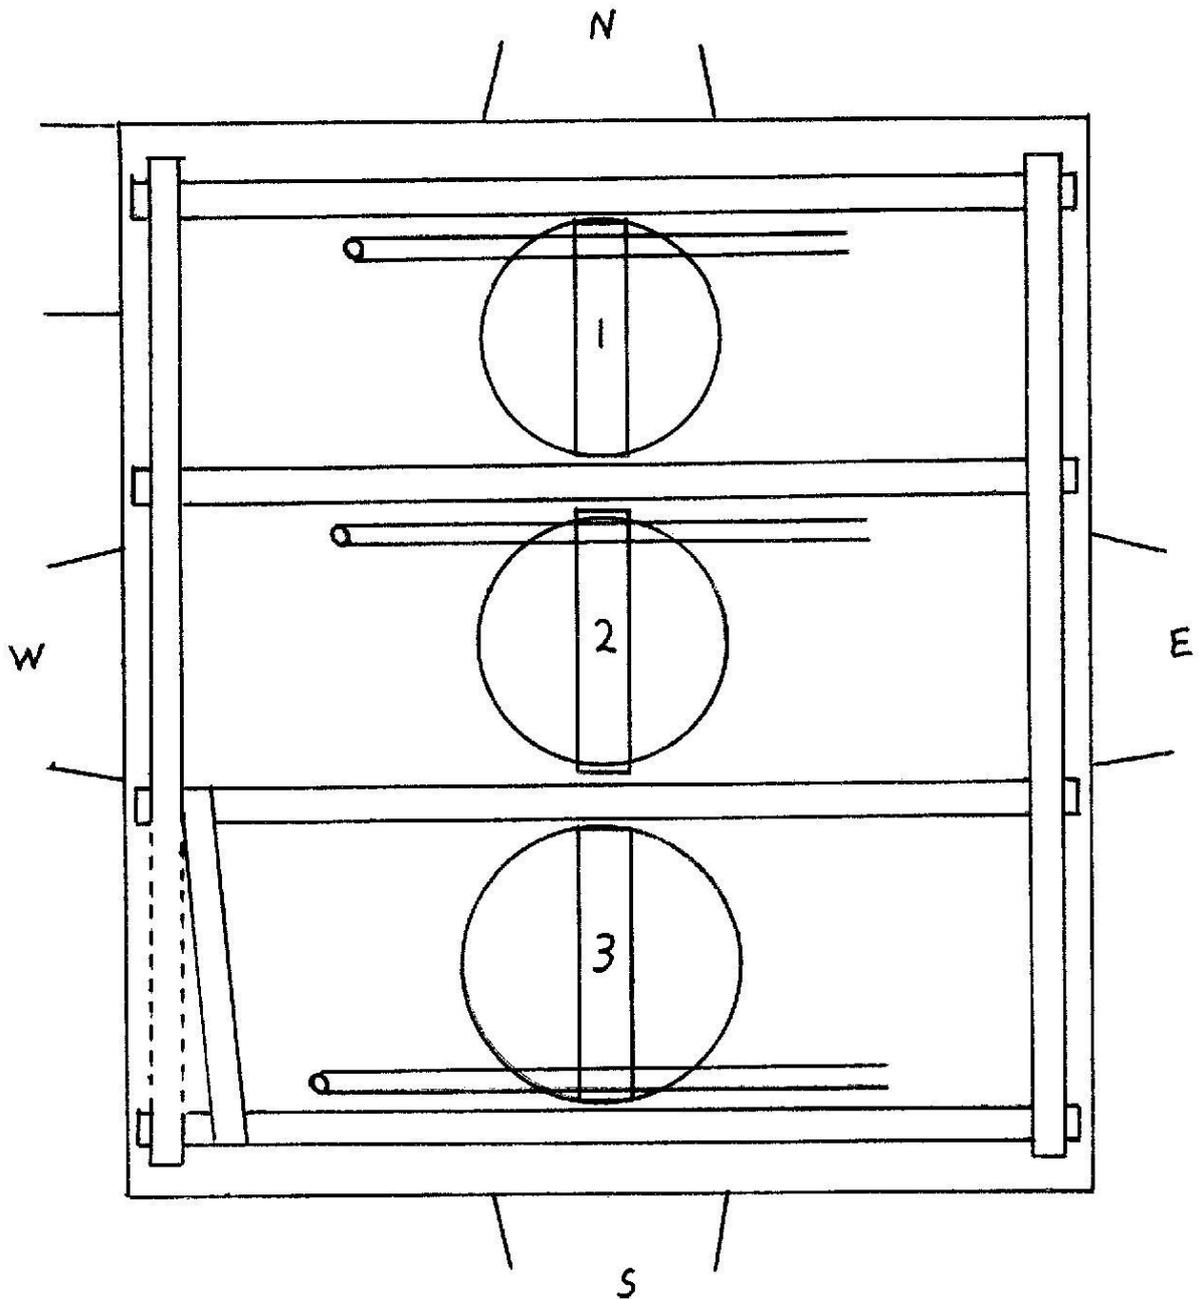
BELL-FRAME LAYOUT AT HUNTSHAW

NB. Dotted lines indicate that section of the frame head which has broken away.
