# Final Ecology Report (Bat Surveys)

St Mary Magdalene Church

Huntshaw

<b>Description:</b>	Final Ecology Report (Bat Surveys)
<b>Produced For:</b>	The Diocese of Exeter
<b>Issue:</b>	Final
<b>Report Reference</b>	ORB0237OBC
<b>Date of Issue:</b>	12/10/2018
<b>Date of Survey Works:</b>	July, August and September 2018
<b>Author:</b>

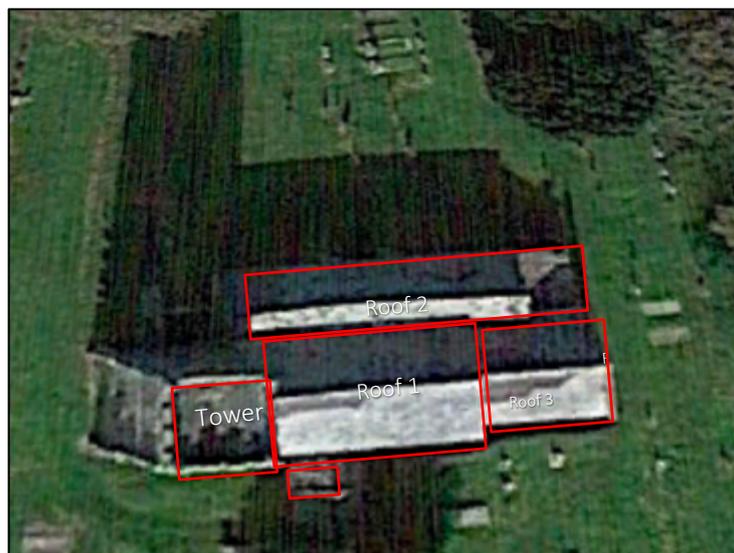
Figure 3 – Aerial view showing roof complex

- 2.1.2 The church is a stone structure with a slate roof. The roof is in a poor condition, with many dislodged slates and damage along the ridges. There are three separate roof structures, all joined by a valley.

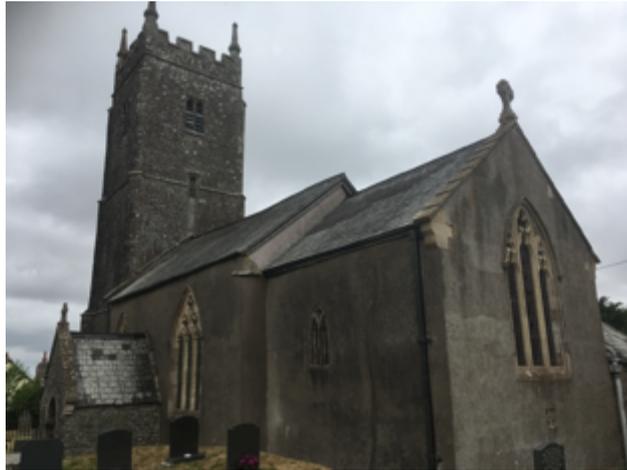
Figure 4 - St Mary Magdalene Church (southern elevation and eastern gable)

- 2.1.3 There is a small C19 porch on the southern elevation with open rafters. The slate tiles in this area are in particularly poor condition. The west tower was built in 1499 and restored in 1862. The walls are tightly pointed in most places. The ventilation windows on the tower have bird mesh that has come apart, allowing access for bats and birds into the bell chamber.

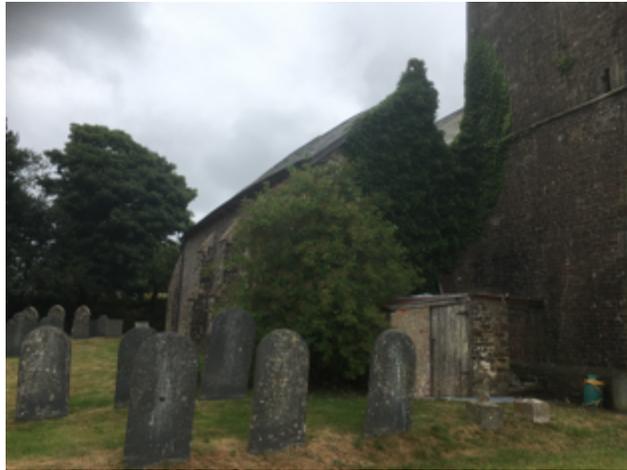
Figure 5 - Ivy cover of northern building

- 2.1.4 The external north wall has multiple gaps along the wall plate where bats and birds could gain access. The north-west corner of the main church has extensive ivy cover that could provide bird nesting habitat.

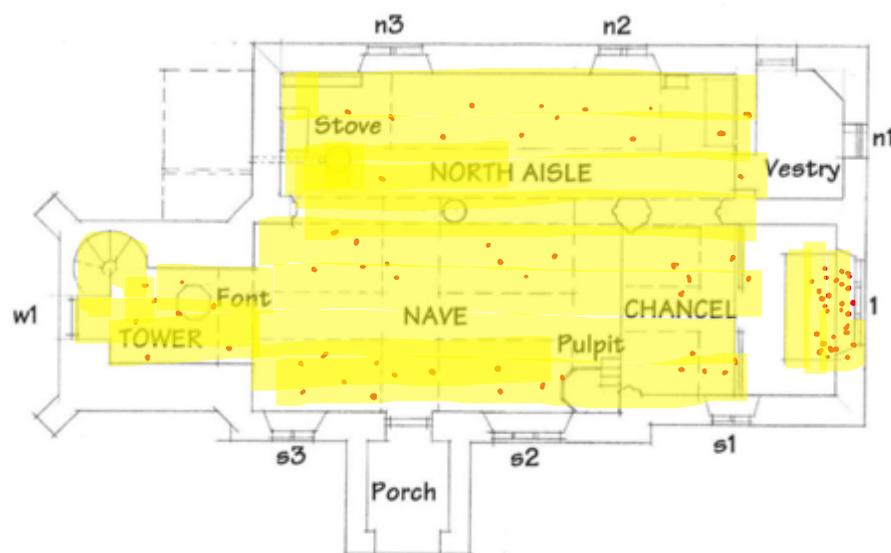
Figure 7 - Plan view showing location of bat droppings

2.3.1 Bats: The preliminary survey concluded that the entire structure has potential to be used by bats. A number of droppings characteristic of long-eared bats and greater horseshoe bats were found in a scattered distribution through-out the nave and aisle areas. Several hundred bat droppings characteristic of lesser horseshoe bats were found under the alter. The droppings were of a varied age. A bat was observed flying in the deadening chamber in the tower. No droppings were found in the vestry or the porch. On this basis the church is **confirmed** as a bat roost for several species of bat. See Figure 7 below for bat dropping locations.

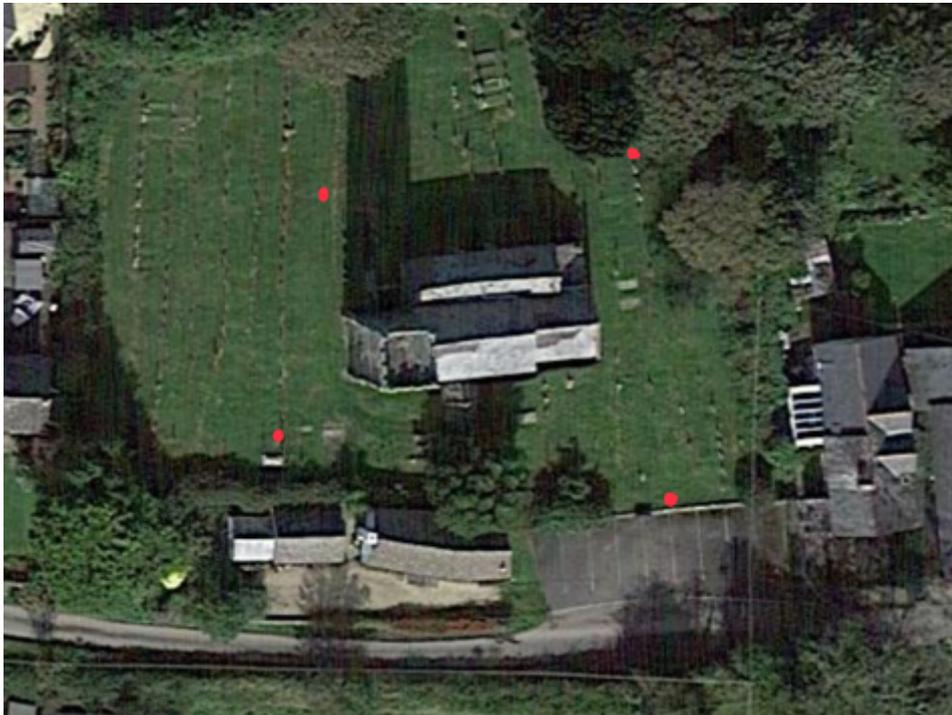
Figure 8 - Surveyor locations

3.1.1 Surveyors were strategically positioned so that they could see areas with high roost potential. It was not possible to see the valley between the two roofs.

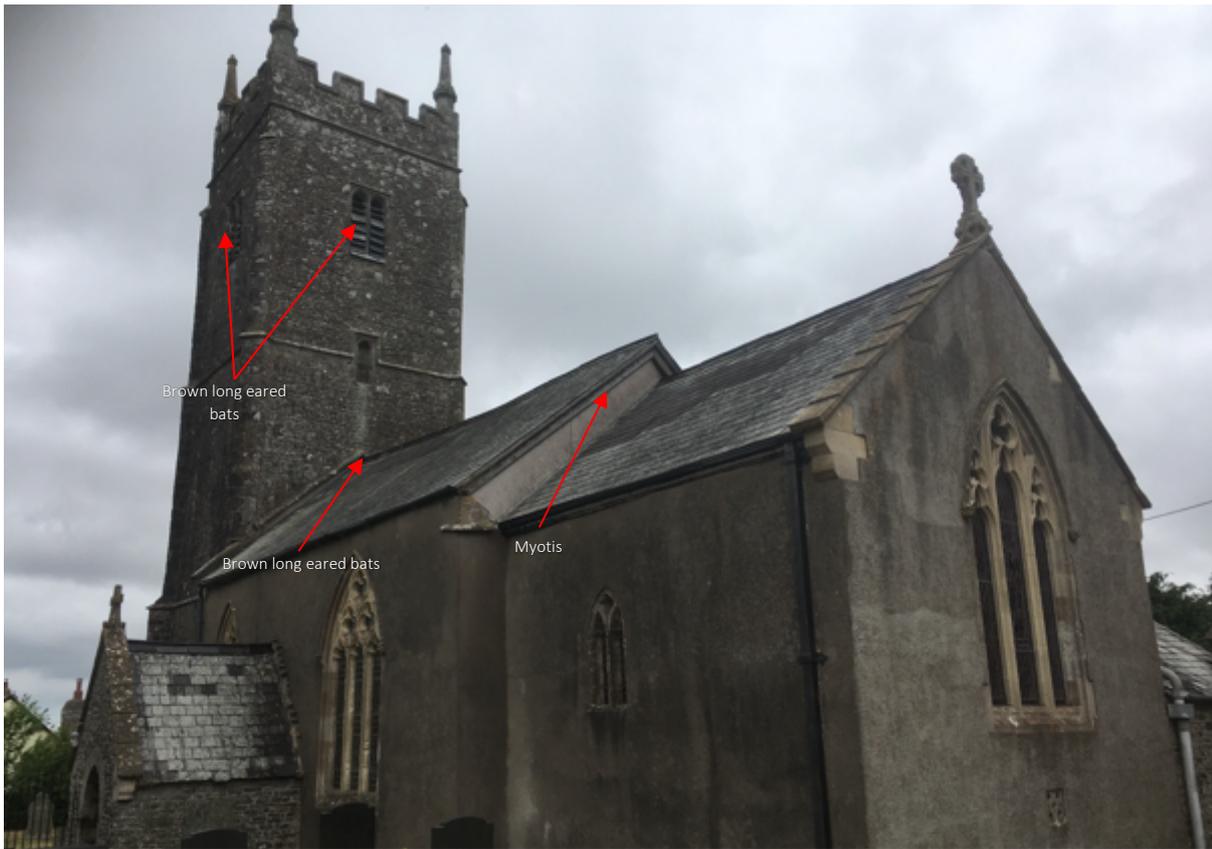
Figure 10 - Photo showing bat roost entry points

Survey	Date	Results
Dusk emergence	21/08/18	4 common pipistrelle bats emerged from various points (see Figure 9) on the roof of the church. 5 <i>Myotis</i> bats emerged from behind bargeboard on able end of roof 1 (see Figure 9) 5 brown long-eared bats emerged from the church in various locations (see Figure 10) 7 brown long-eared bats emerged from the tower (see Figure 10)
Dawn re-entry	13/09/18	5-6 brown long-eared bats flew in under a line of lifted roof tiles at the junction of the tower and the main roof. Bats were recorded displaying courtship behaviours.
