Inspection of Churches Measure 1955

Church of St Mary Magdalene, Huntshaw

Diocese of Exeter

Inspected by **John Alexander** BA DipArch MSc RIBA AABC

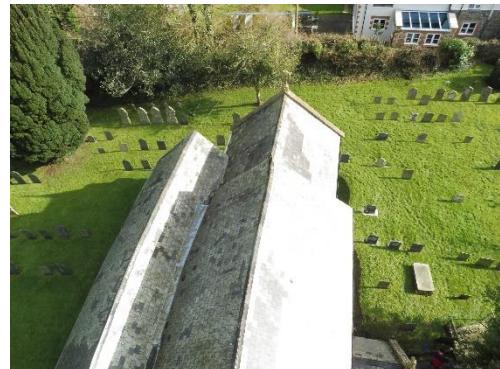
- 31.1 Generally standing headstones and monument, table tombs in a cut grass churchyard. This generally slopes to the west and the southern boundaries and appears generally well maintained.
