# **CHURCH OF ST MARY MAGDALENE**

# **HUNTSHAW**

## **REPORT ON THE CONDITION OF THE BELLS, BELL-FRAME AND FITTINGS**

Inspection carried out on Tuesday 7<sup>th</sup> March 2017 by David Hird (Assistant to the Exeter DAC Consultant on Bells and Clocks) and Ian Campbell and Ian Smith (Bells and Belfries Advisors to the Guild of Devonshire Ringers), assisted by Robert Franklin; met by Peter Denard (Church Treasurer). This report also makes reference to the findings of Prebendary John Scott, former Bells Advisor to the Diocese of Exeter, from his visit in December 1979.

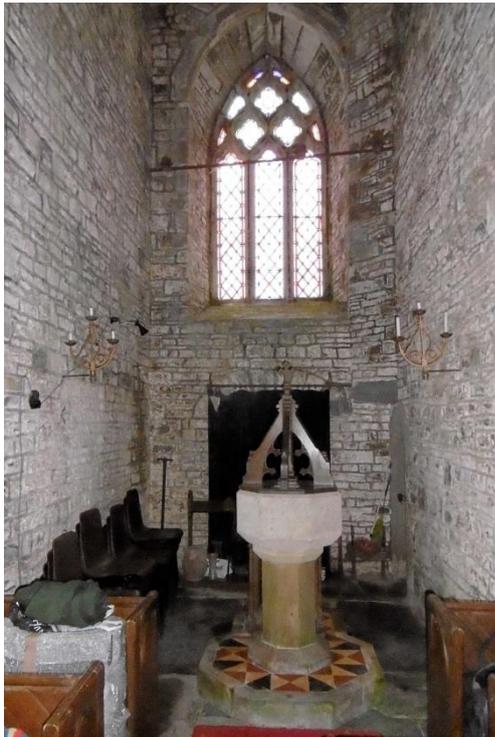
*The Ground Floor Chamber*

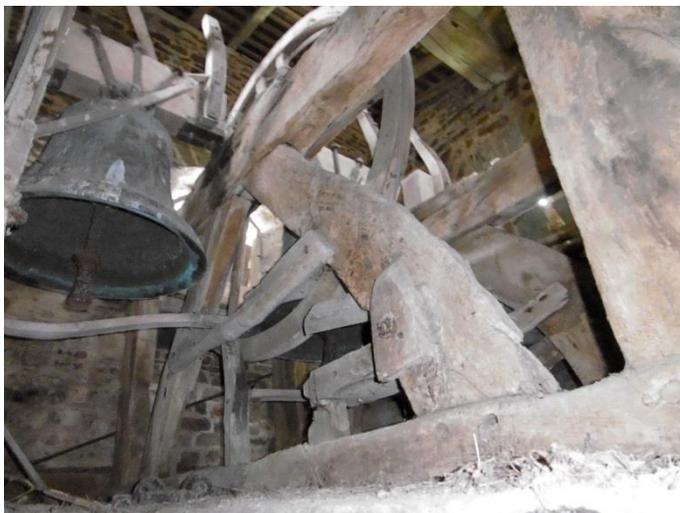
There is significant decay in some parts of the frame; indeed part of the return head at the W end of the tenor pit broke away as we were recording it. Having said that, the frame stands well and is reasonably robust. Various strengthening measures have clearly been taken over

*The Frame Truss between the Treble and Second Bells*

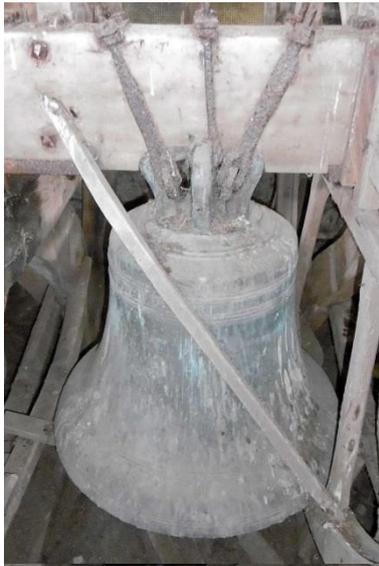
Thus, taking the note of the tenor bell as the datum, the second bell is very flat and the treble is rather sharp, with nearly an extra half semi-tone between them.

*The Treble Bell by "W.K."  
1634*

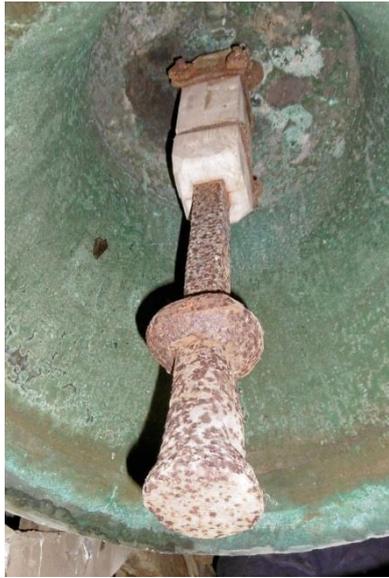
The **Clappers** are quite ancient, having T-shaped tops enclosed in hardwood boxes, the boxes pivoting on the clapper staples. The treble clapper has a square shaft and roughly square flight; the second clapper has a round shaft and flight; and the tenor clapper has a roughly round shaft and flight. All are somewhat crudely forged. The flights are all quite long, compared with modern clappers, and the balls are very squat, particularly that on the tenor. All the clappers exhibit considerable sideways play of between 7 inches and 13½ inches, indicating that the suspensions are somewhat worn.

*The Treble Clapper*

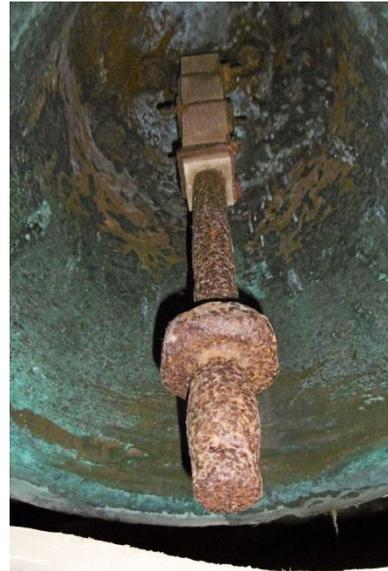
*The Tenor Clapper*

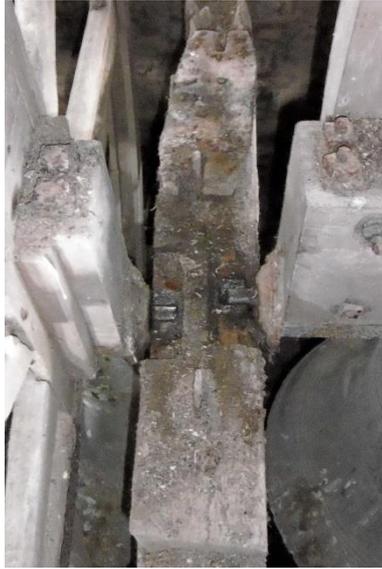
The **Bearings** are plain bearings consisting of brass cups set in cast iron housings and recessed into the frame heads. They all appear to be in relatively good condition and would merely benefit from cleaning.

*Bearings of the Treble and Second Bells*
